Scotts Creek Watershed Assessment

A Document of the Scotts Creek Watershed Council

February 2010

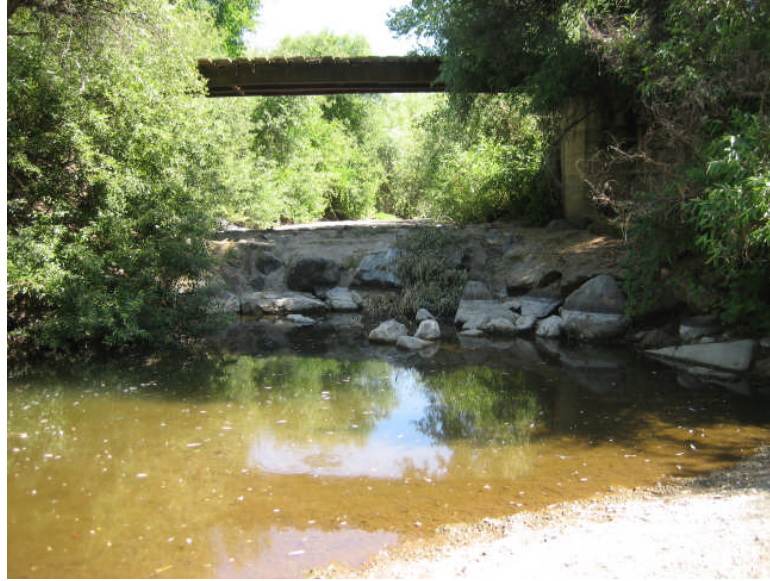
Figure 6-1 Bridge footing and Decker Bridge, July 6, 2007.
Photo by Erica Lundquist

A 1960 survey found a man-made barrier in the form of a rock masonry dam approximately 5 feet tall and 30 feet long on the South Fork of Scotts Creek approximately $\frac{3}{4}$ mile downstream from the Hopland Grade Highway crossing (DFG 1960b). Another barrier present today, but not noted in a 1959 DFG stream survey, is a 4 foot high man-made barrier created by the footing of a private bridge on Scotts Creek. This barrier is located approximately 13.4 miles upstream of the mouth of Scotts Creek in the north end of Scotts Valley (Figure 6-1, Plate 2). A culvert under Hendricks Creek road at an unidentified tributary to Hendricks Creek is also a barrier to fish passage. A complete survey of man-made barriers to fish passage has not been done for the watershed.

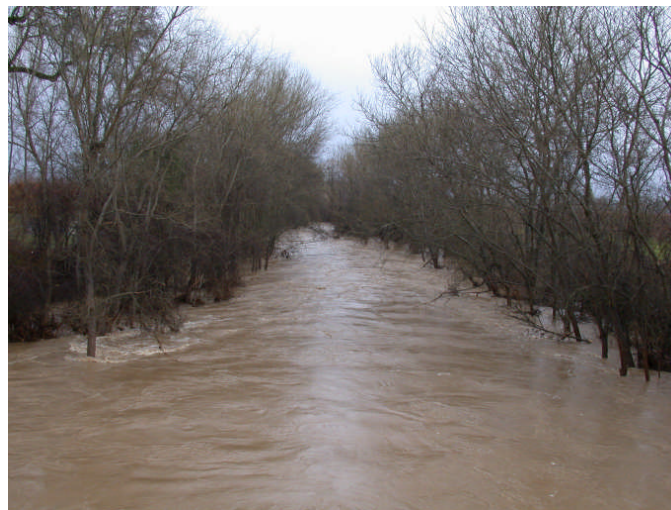
Figure 6-4 High flow in Scotts Creek north of Scotts Valley Bridge during the 2006-2007 "New Years Flood". Photo by Greg Dills.

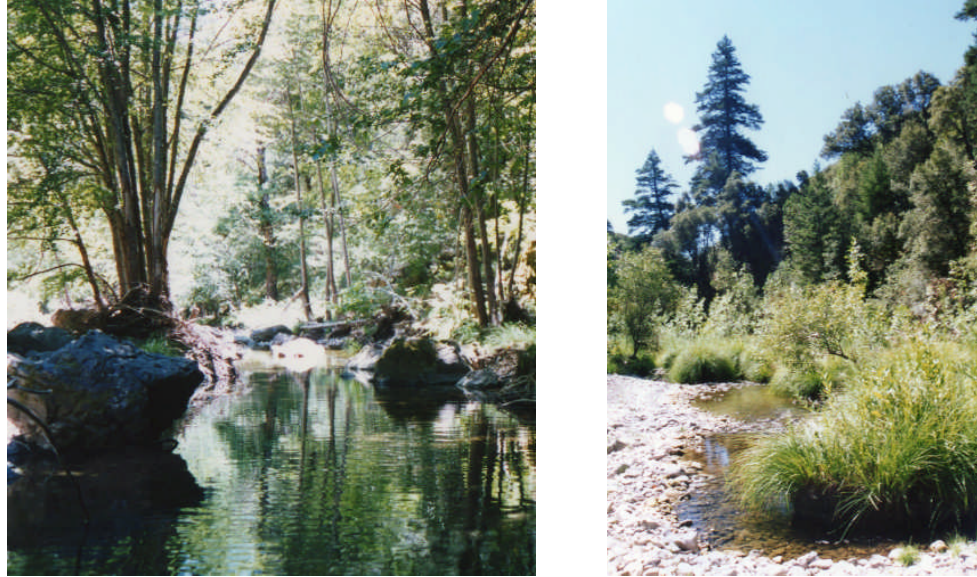
Figure 7-3 Shaded and unshaded portions of Upper Scotts Creek, 1996.
Photos by Jared Hendricks, Jr.

A 1997 survey described Scotts Creek from Willow Creek to the confluence with the South Fork. “The streambed in the surveyed reach was generally flat-bottomed V-Shape, with side areas gradually rising to steep canyon walls. The stream channel was generally sinuous, dominated by low gradient riffles and pools...Vegetative cover adjacent to the stream consisted mainly of clusters of willow and alder, with extensive stands of sedges that concealed the stream channel in many of the more open areas” (DFG 1997a). No mention of oaks and other hardwoods on the streambanks is made in this survey. Descriptions of surrounding vegetation are similar in the two surveys.

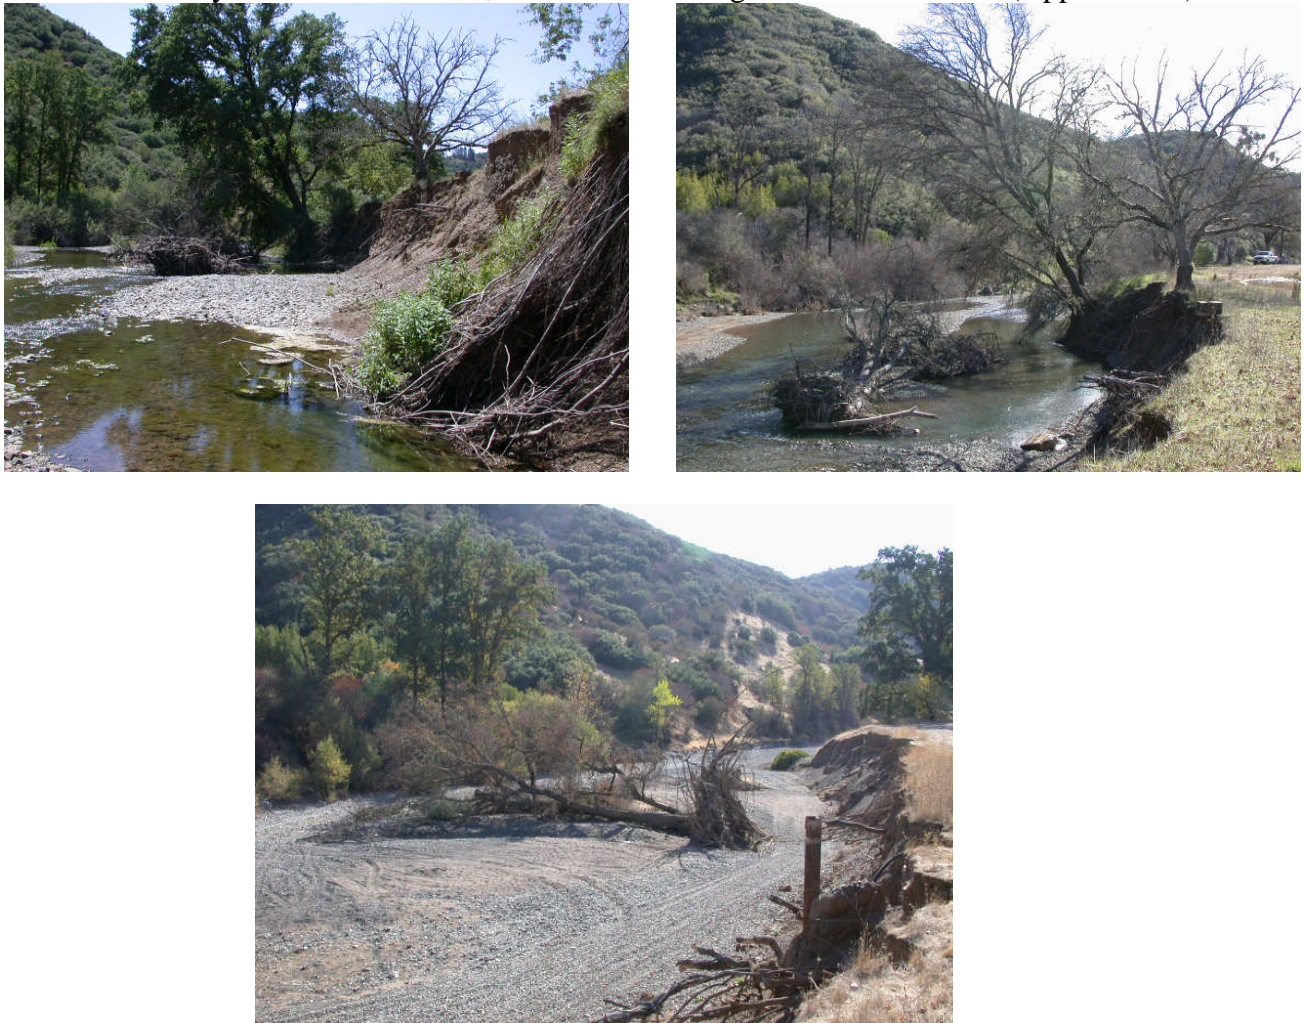
Figure 7-4 Streambank erosion on terrace near Scotts Creek confluence in May 2004 (top left), February 2005 (top right) and October 2006 (bottom). *Photos by Greg Dills.*

Streambank erosion from the terraces in the confluence area is a continuing problem and has been documented in photographs over the past 5 years ([Figure 7-4](#), Greg Dills, personal communication). The most visible demonstration of this erosion in the aerial photographs is the terrace indicated by an arrow in 1970, which is no longer visible in 2006 ([Appendix D](#)).

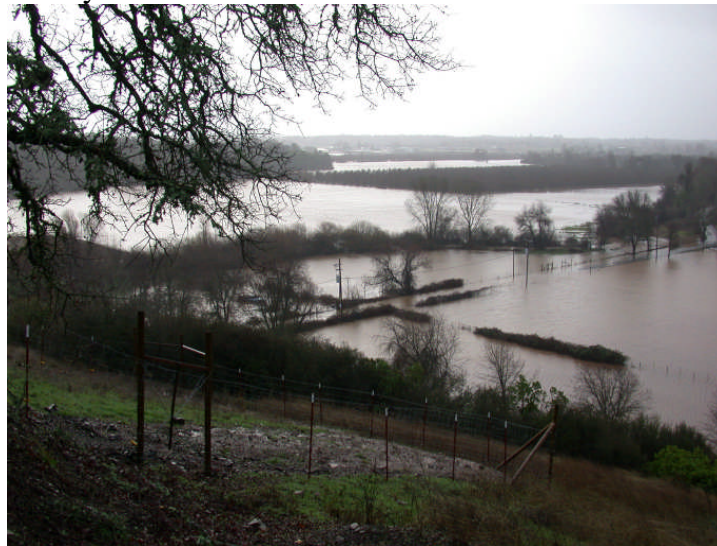
Figure 7-6 Extensive flooding occurred during this December 31, 2005 storm. View is toward southeast with Hendricks Rd. in foreground. Photo by Greg Dills.

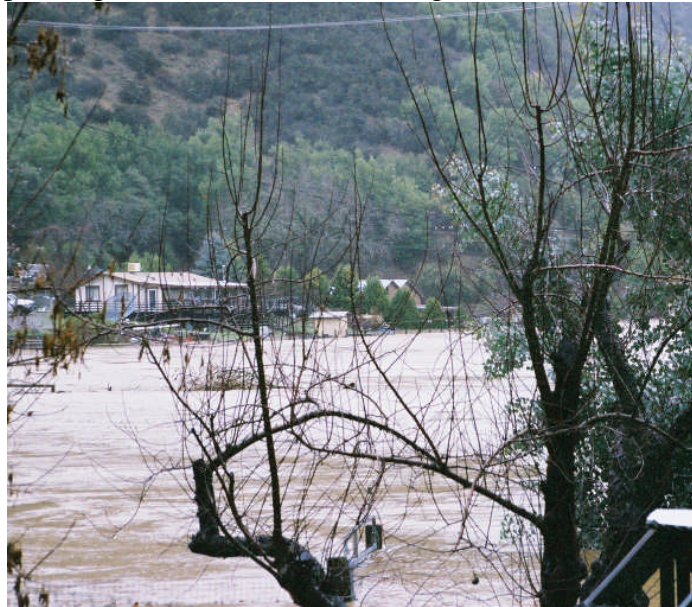
Figure 7-7 Flooding during high flows in narrow portion of Scotts Valley, January 1, 2006. High flows frequently lead to flooding outside the stream channel as in this photo. Photo by Greg Dills.

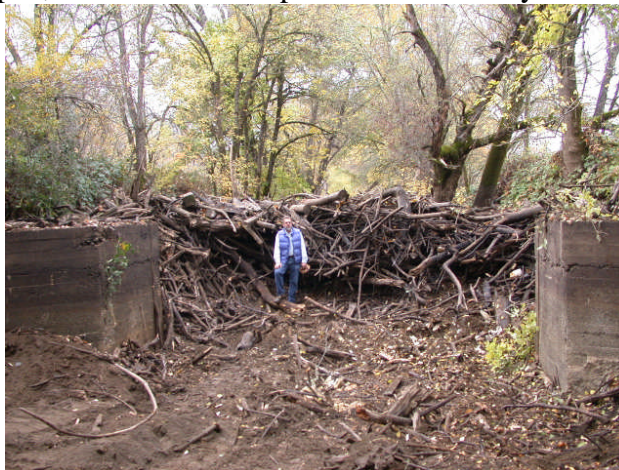
Figure 7-9 Debris jam at a flashboard dam prior to removal in 2006. *Photo by Greg Dills.*

High streamflows in 2005 created significant debris jams from the Mendenhall property and continuing 1 mile downstream. The West Lake RCD applied for and received FEMA funding to remove approximately 7,400 yd³ of debris in November 2006 ([Figures 7-9, 7-10, 7-11](#)). The debris was removed, chipped, and used for compost at a local vineyard.

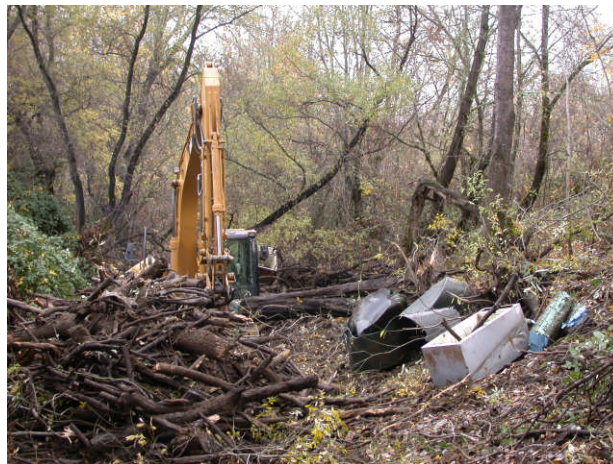
Figure 7-10 Clean up of both woody debris and trash during the 2006 FEMA project. *Photo by Greg Dills*

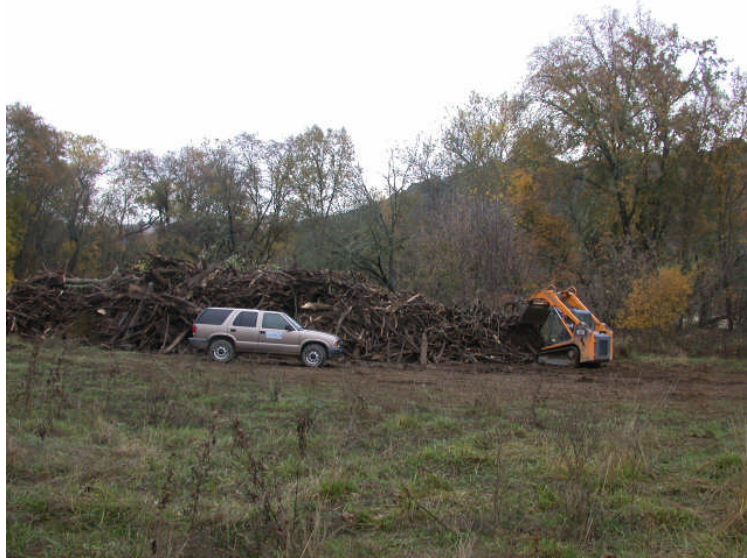
Figure 7-11 One of the debris piles from the project, 2006. *Photo by Greg Dills.*

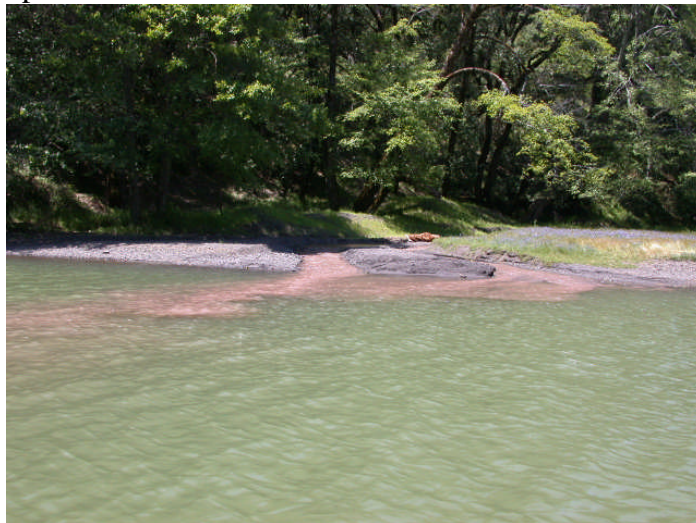
Figure 8-1 Streamflow carrying sediment into Upper Blue Lake. *Photo by Greg Dills.*

Water quality samples are taken near the permanent stream gages to determine a relationship between streamflow rate and the amount of sediment or nutrients suspended in the water. Because of the great variability of rainfall patterns in California, it is necessary to continue these studies over many years (Florsheim J. 2007). The studies are also continued in order to find out whether nutrient and sediment transport is changing due to changing land management practices.

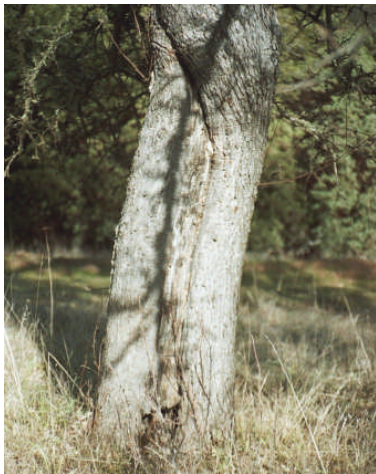
Figure 10-2 Fire scarred blue oak trunk, Scotts Creek Watershed. *Photo courtesy of Jared Hendricks, Jr.*

Some landowners continue to use prescribed burning to reduce the threat of large wildfires and improve wildlife habitat. Jared Hendricks Jr. uses prescribed burning to increase deer forage availability and streamflows. He has found that many blue oak groves were fire scarred by the severe wildfire of 1981. Fall prescribed burning has the potential to re-ignite the dead wood on these trees and kill them. Therefore, he uses spring prescribed burns to clear areas near the groves and protect this important food resource. He tries to encourage three important habitat components for deer, new growth on recently burned chaparral, the fall acorn crop, and both of these in proximity to water ([Figures 10-2, 10-3](#)).

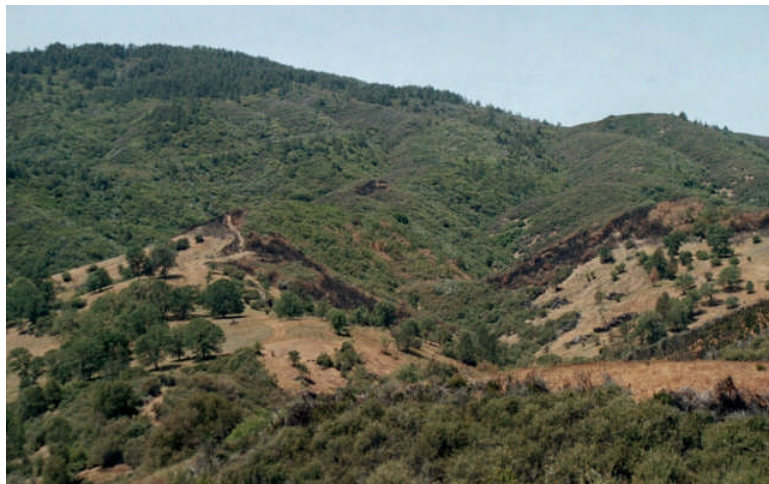
Figure 10-3 Prescribed burn areas adjacent to blue oak woodlands, Scotts Creek Watershed. *Photo courtesy of Jared Hendricks, Jr.*

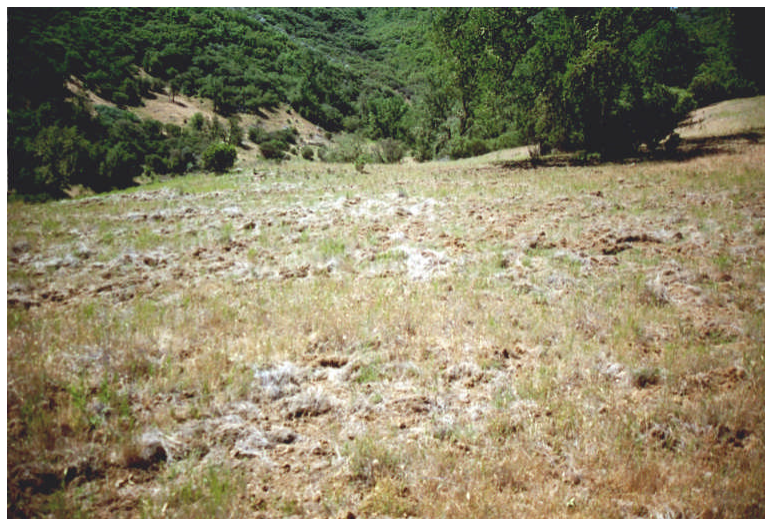
Figure 12-1 Soil disturbance caused by wild pigs in the Scotts Creek Watershed. Photo by Jared Hendricks Jr.

Examples of non-native mammals that belong to the group associated with increased negative consequences and are often referred to as “invasive” species include the roof rat, Norway rat, and feral house cats, all of which prey on native birds and small mammals. Feral pigs cause environmental damage by rooting the soil, which causes erosion and promotes invasive/exotic weed establishment, and readily feeding on native wildlife and vegetation ([Figure 12-1](#)). At the same time, feral pigs provide popular hunting activities. The California DFG reported 5,438 were taken in the state in 2005/2006 (Kreith, M. 2007).

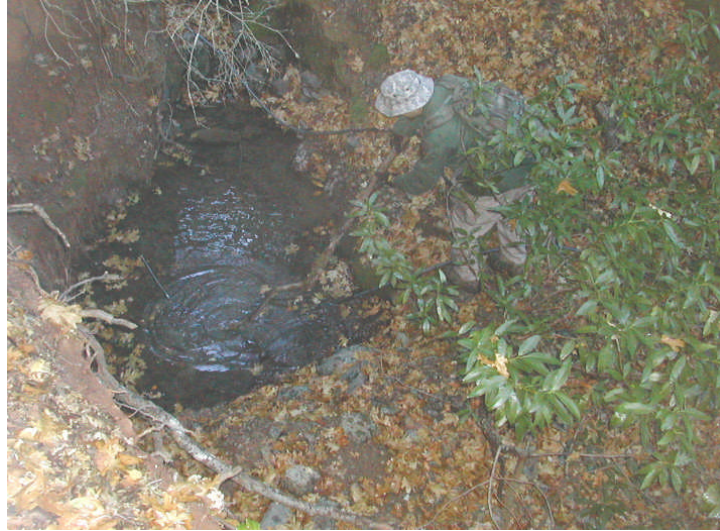
Figure 15-1 Water diversion from ephemeral stream at pot garden cleaned up in the upper Scotts Creek Watershed, 2008. *Photo by Gary Sharpe, BLM.*

Marijuana Growing - Illegal marijuana growing operations in the upper watershed may have substantial localized impacts on watershed health. Lake County has led the state’s Campaign Against Marijuana Production, CAMP, in the number of plants seized from 2006-2008. In 2008 500,000 plants were seized in Lake County, mostly from public lands. Marijuana growing operations frequently rely on water diversions from streams and may significantly de-water small streams during summer months ([Figure 15-1](#)). There have been observations of ponds built adjacent to streams for fertilizer mixing, which cause both sediment and fertilizer inputs to streams ([Figure 15-2](#)). Diesel spills from generators used to power pumps or other equipment have also contaminated waterways (Anderson 2008, Edmison 2007).

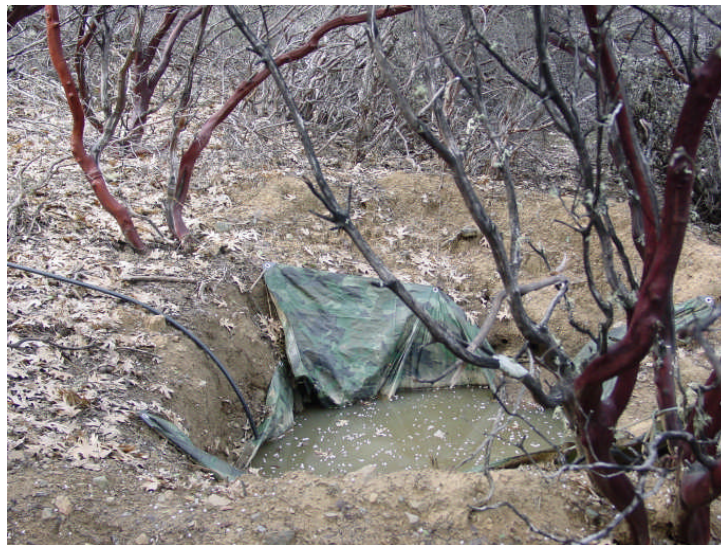
Figure 15-2 Pit built for fertilizer mixing and/or water diversion near Eight Mile Valley, 2008. *Photo by Gary Sharpe, BLM.*

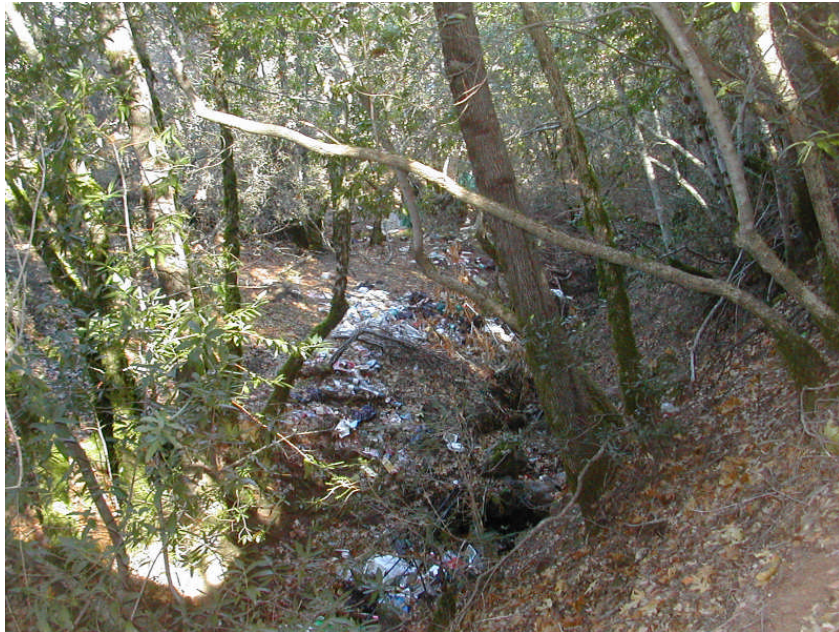
Figure 15-3 Trash at pot garden clean up site in Scotts Creek headwaters, 2008. *Photo courtesy Gary Sharpe, BLM.*

Clean up costs for these sites are considerable with “fertilizers, pesticides, rodent poison, propane tanks, food, human waste, tarps, and plastic tubing... widely scattered in remote regions” (Anderson 2008) (Figure 15-3). Although many illegal marijuana growing operations are located on public lands, public agencies receive only a fraction of the funds needed to clean them up. Gary Sharpe, Associate Field Manager at the Ukiah BLM office, estimates that “We could easily go through \$1 million a year for the next five years...And that’s if (the pot cultivation) stopped” (quoted in Anderson 2008).
